Frequency Resolved Acoustic Imaging in the Audio Frequency Interval: Panel Paintings

Paola Calicchia[1], Patrizio Verardi[1], Lucilla Di Marcoberardino[1], Sara De Simone[1]

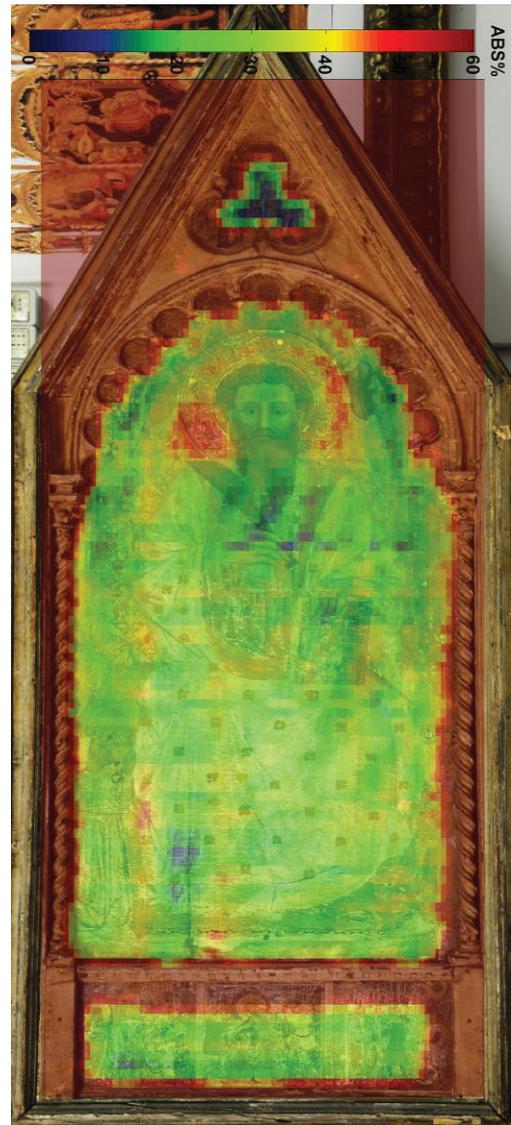
Fig. 3. St. Bartholomew, IAI over the range (1 – 16) kHz.

Observing the areas highlighted by the color levels shading from yellow to red, a variety of elements seem to combine in the *integrated acoustic image*, clearly visible in Fig. 3. Few yellow vertical lines on the left, or the horizontal line in the central part on the predella, are present together with a number of red spots, among which those on the halo are particularly evident. The *frequency resolved acoustic images*, Fig. 4 and Fig. 5, suggest that in a certain measure it can be possible to separate the effects of different causes of deterioration. For example, in Fig. 4 (top) the image at the lower frequency band unveils a noticeable weakness in the upper half of the panel, also disclosing a sort of periodic structure, found to be compatible with the periodicity of the cradle structure, and progressively disappearing in the higher frequency band, Fig. 4 (bottom). In Fig. 5, slightly

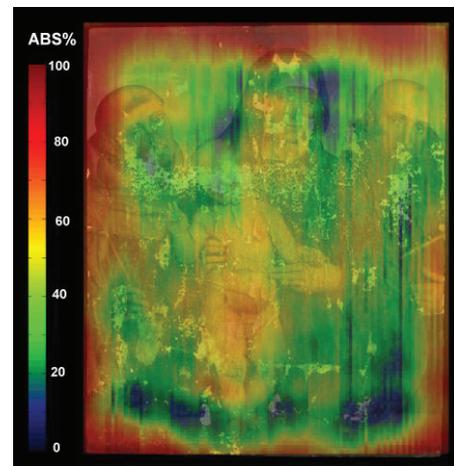
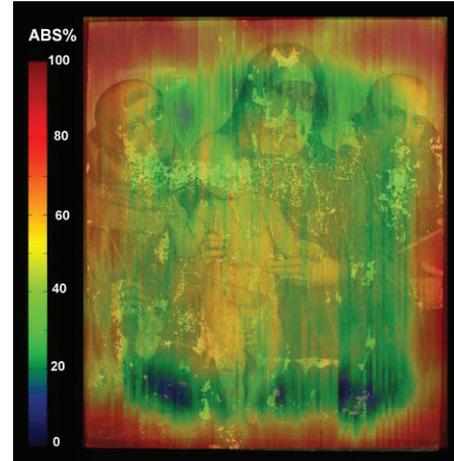
Fig. 5. Madonna with Child and two Saints, FRAI at 4.0 kHz (top), and at 10 kHz (bottom).

different areas appear in the two images: a red sector on the front of the saint on the left and a long horizontal area running below the knees of the child appear only in the high frequency image (bottom); furthermore the red area on the hand of the other saint on the right is particularly visible at the low frequency image (top).

Besides, more structured features such as straight lines or grids come out in the images of the two paintings (*St. Bartholomew* and *Venus and Mars*) characterized by a more composite substrate (multiple axes, junctions, cradle). On the contrary, for the third case in Fig. 5, only critical areas related to specific portions of the painted surface seem to emerge. In any case, as expected, finer details and more defined contours appear as frequency reaches higher values: for example in Fig. 4 (bottom) the critical part restricts to a narrow horizontal line, seemingly corresponding to a flaw in the upper board.
